Storm Water Construction General Permit Inspection Report

RWQCB - Region 5S

WDID # 5S03C337319

Pine Grove Bluffs

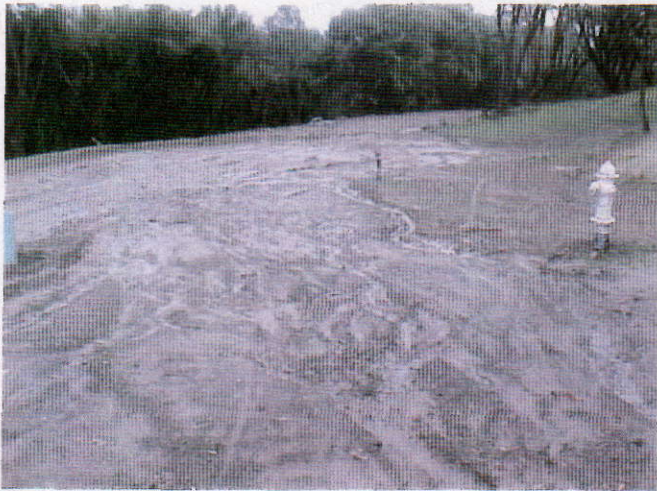
Figure 1:

Significant storm water management problems were observed during the site inspection. Staff observed a great deal of erosion throughout the entire length of the roadway. In several areas sediment laden storm water was observed discharging from the construction site (see inspection photographs). Tony Rapini was working on the BMPs during the site inspection and he was advised to solve the problems on the roadway.
